INDOOR AIR QUALITY ASSESSMENT

**Grafton Municipal Building/Intermediate School
30 Providence Road
Grafton, Massachusetts**

Prepared by:
Massachusetts Department of Public Health
Bureau of Environmental Health Assessment
June, 2000

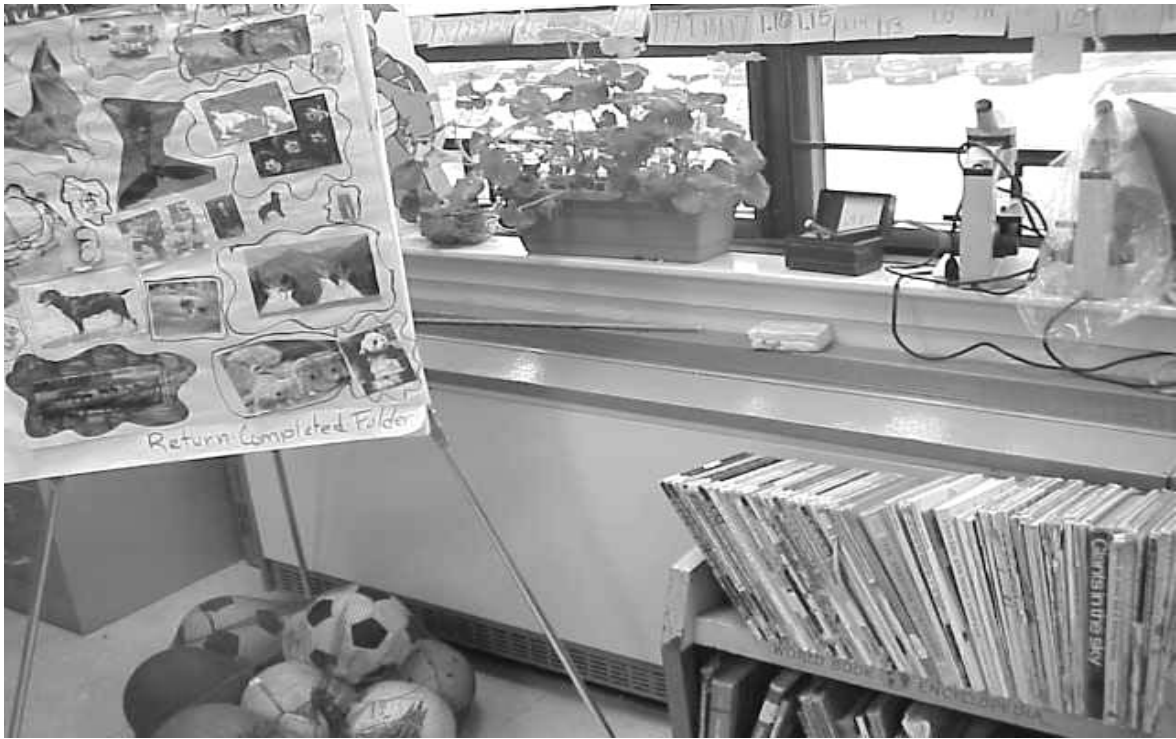
Picture 1

Fresh air in classrooms and most office space is supplied by a unit ventilator (univent) system. A univent draws fresh air from a vent on the exterior of the building and air from the classroom (called return air) through a vent in the base of the unit ([see Figure 1](#)). Fresh air and return air are mixed, filtered, heated and expelled into the classroom through a fresh air diffuser located on the top of the unit. Univents were deactivated throughout the building by building maintenance the day of the assessment. Obstructions to airflow, such as paper and boxes stored on top of univent air diffusers as well as furniture and boxes in front of univent return vents were also noted in several areas (see Picture 1). In order for univents to provide fresh air as designed, univent air diffusers and return vents must remain free of obstructions. Importantly, these units must remain activated while the building is occupied.

Several rooms had a number of plants. Plant soil and drip pans can serve as source of mold growth. Plants are also a source of pollen. In some areas flowering plants were noted near univent air diffusers (see Picture 1). Plant clippings and debris were noted inside the air diffuser in classroom 25 (see Picture 9). Plants should be located away from ventilation sources to prevent aerosolization of dirt, pollen or mold.

**Classroom Univent Obstructed by Various Items
Also Note Plant over Univent Air Diffuser**

5. Remove all blockages from univents and exhaust ventilators to ensure adequate airflow.
6. Once both the fresh air supply and exhaust ventilation are functioning, the systems should be balanced by a ventilation engineer.

9. Move plants away from univents in classrooms. Examine drip pans for mold growth and disinfect areas of water leaks with an appropriate antimicrobial where necessary.

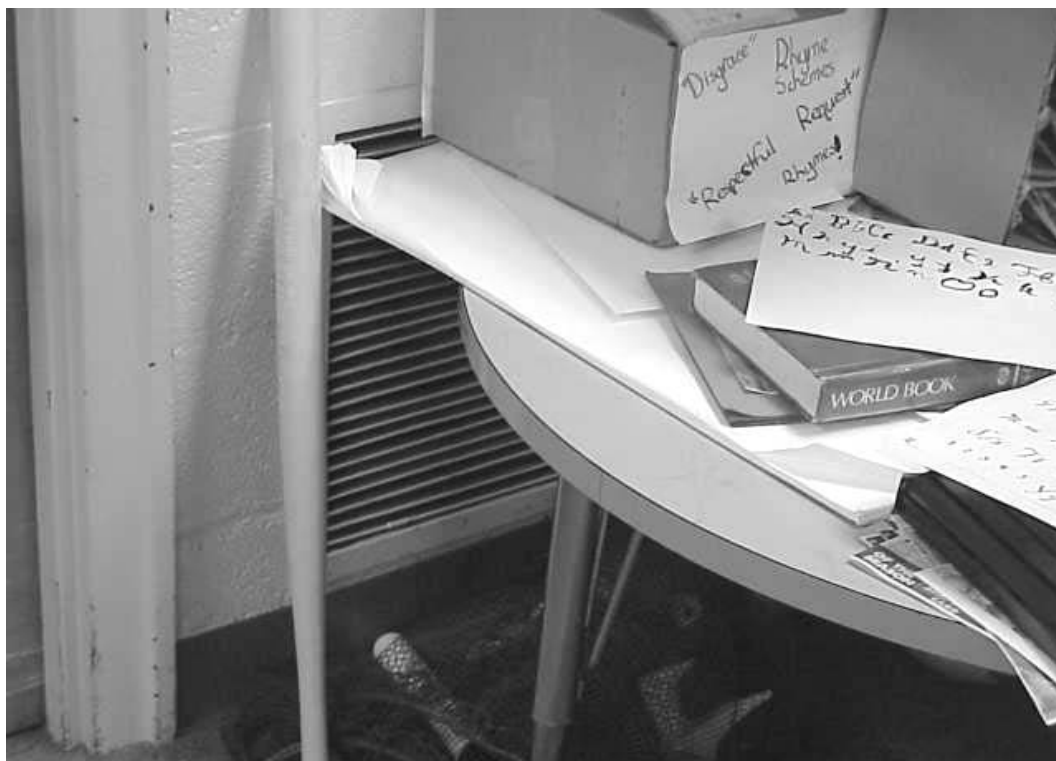
Picture 2

Exhaust ventilation is provided by grilled, ducted wall vents. Exhaust vents were noted to be off or drawing weakly in a number of areas, which can indicate that exhaust ventilation was turned off, or that rooftop motors were not functioning. BEHA staff examined exhaust motors on the roof and found that the exhaust motors were operating. This would indicate that although motors were operating, they may not be functioning properly or that obstruction to airflow inside the ductwork may exist. Exhaust vents were also obstructed by bookcases, desks, chairs, file cabinets and other items (see Pictures 2 & 3). As with the univents, exhaust vents must remain free of obstructions to function properly.

Exhaust Vent Obstructed by Table

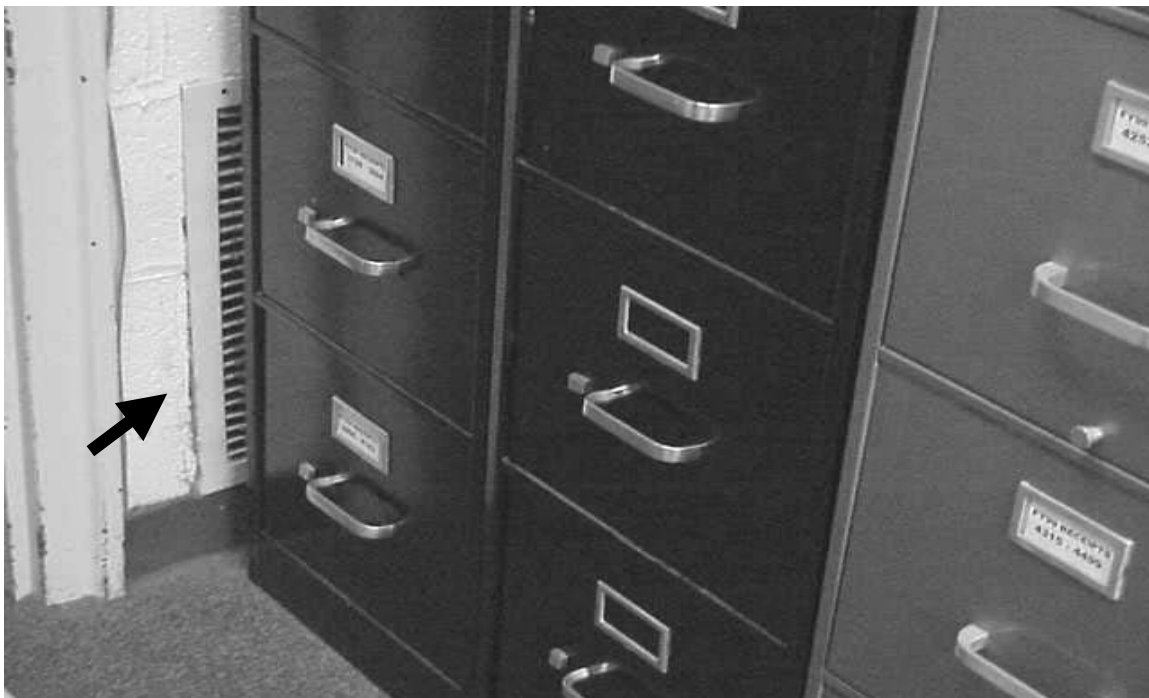
Picture 3

Exhaust Vent Obstructed by File Cabinet

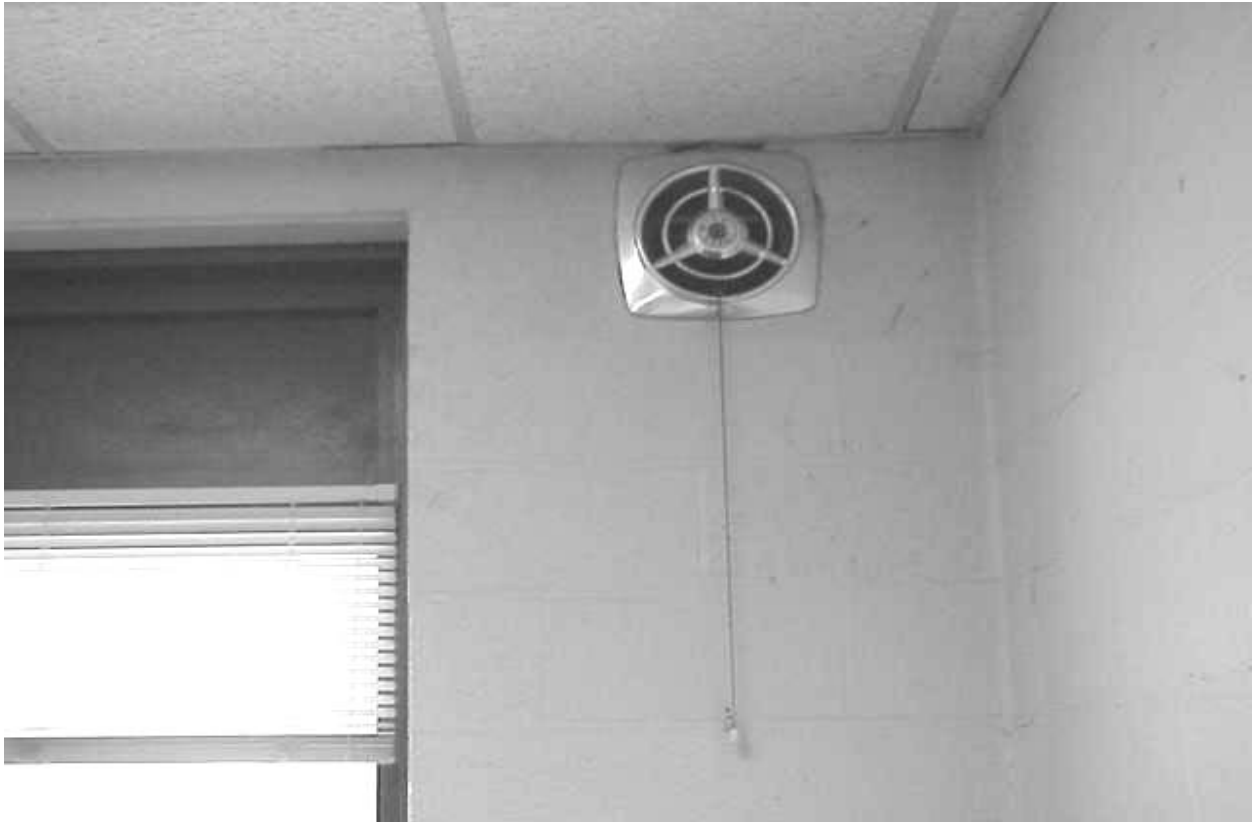
Picture 4

The art room and Teacher's lounges each contained a wall-mounted local exhaust vent (see Picture 4). BEHA staff were unable to activate these fans via the pull chain mechanism. Without functioning exhaust ventilation in these rooms, heat and odors can build up, which can lead to complaints of poor indoor air quality. Maintenance personnel report that mechanical ventilation in the gymnasium was not functional and that it was on a repair list. In addition, mechanical ventilation in the cafeteria was operable, however, it was not activated during the assessment, which would account for the elevated level of carbon dioxide measured in the room during the lunch period (150 + occupants).

**Non-Operable, Wall-mounted Local Exhaust Fan Noted in Teacher's Lounge
(Similar Fan Noted in Art Room)**

14. Re-activate or replace wall-mounted exhaust vent in art room and teacher's lounge to help circulate air and remove heat and odors.
15. Relocate student drop off area or have busses shut off engines after five minutes as required by Massachusetts General Laws 90:16A. To avoid entrainment of vehicle exhaust (see Picture 12), post signs in parking area instructing employees not to back in.

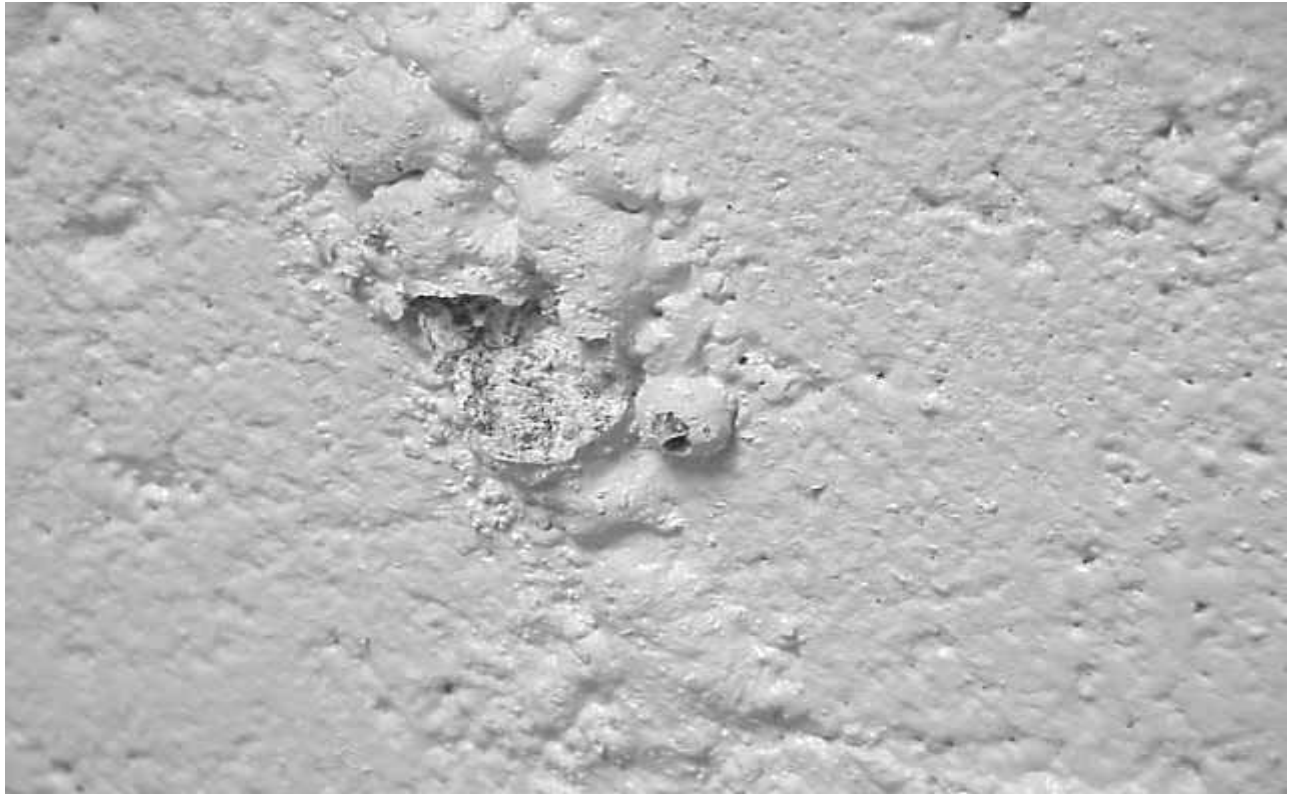
Picture 5

A wall in the second floor prep room off of classrooms 22, showed signs of efflorescence (see Picture 5). Efflorescence is a characteristic sign of water damage to building materials, but it is not mold growth. As moisture penetrates and works its way through building materials, water-soluble compounds dissolve, creating a solution. As this solution moves to the surface, the water evaporates, leaving behind white, powdery mineral deposits. Water-damaged building materials, if wetted repeatedly, can be a medium for mold growth. A number of rooms had water-stained ceiling tiles (see Picture 6), which are evidence of historic roof or plumbing leaks. Water-damaged ceiling tiles can provide a

**Efflorescence (i.e., Mineral Deposits) and Bubbled Paint
Noted in the Classroom 22 Prep Room**

8. Repair/replace any water-stained ceiling tiles and wall plaster. Examine the area above and around these areas for mold growth. Disinfect areas of water leaks with an appropriate antimicrobial. Determine source of water entry through wall and eliminate.

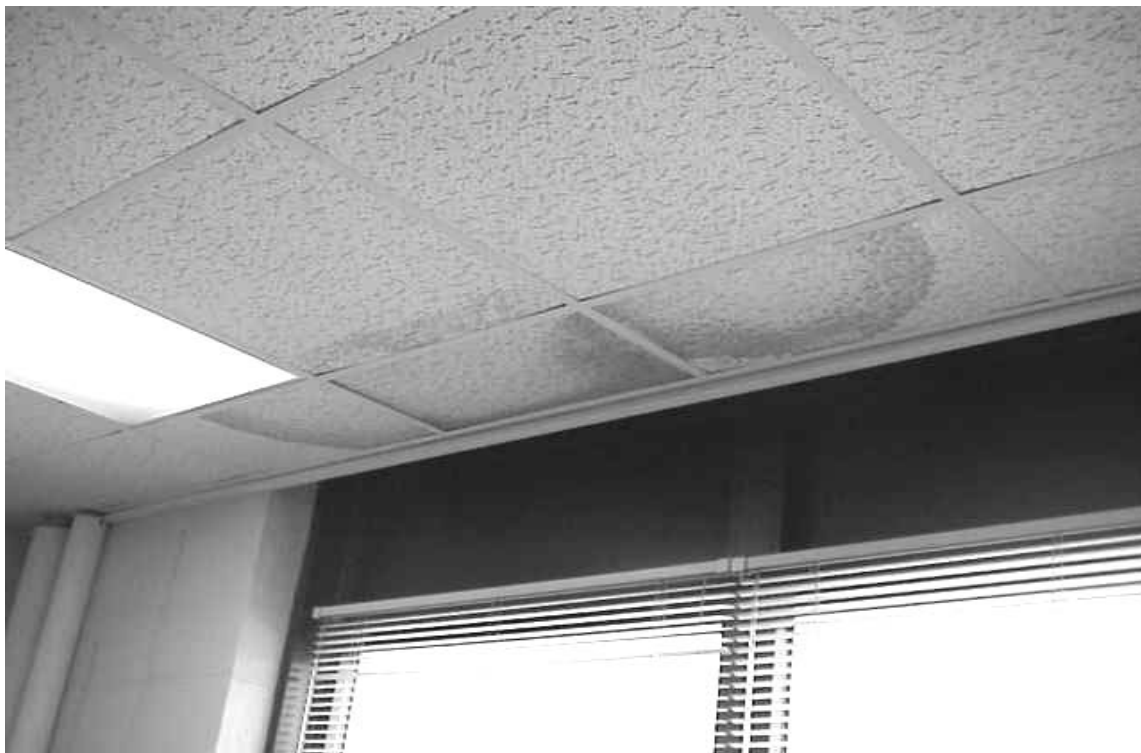
Picture 6

source of mold and mildew and should be replaced after a water leak is discovered and repaired.

Water Damaged Ceiling Tiles

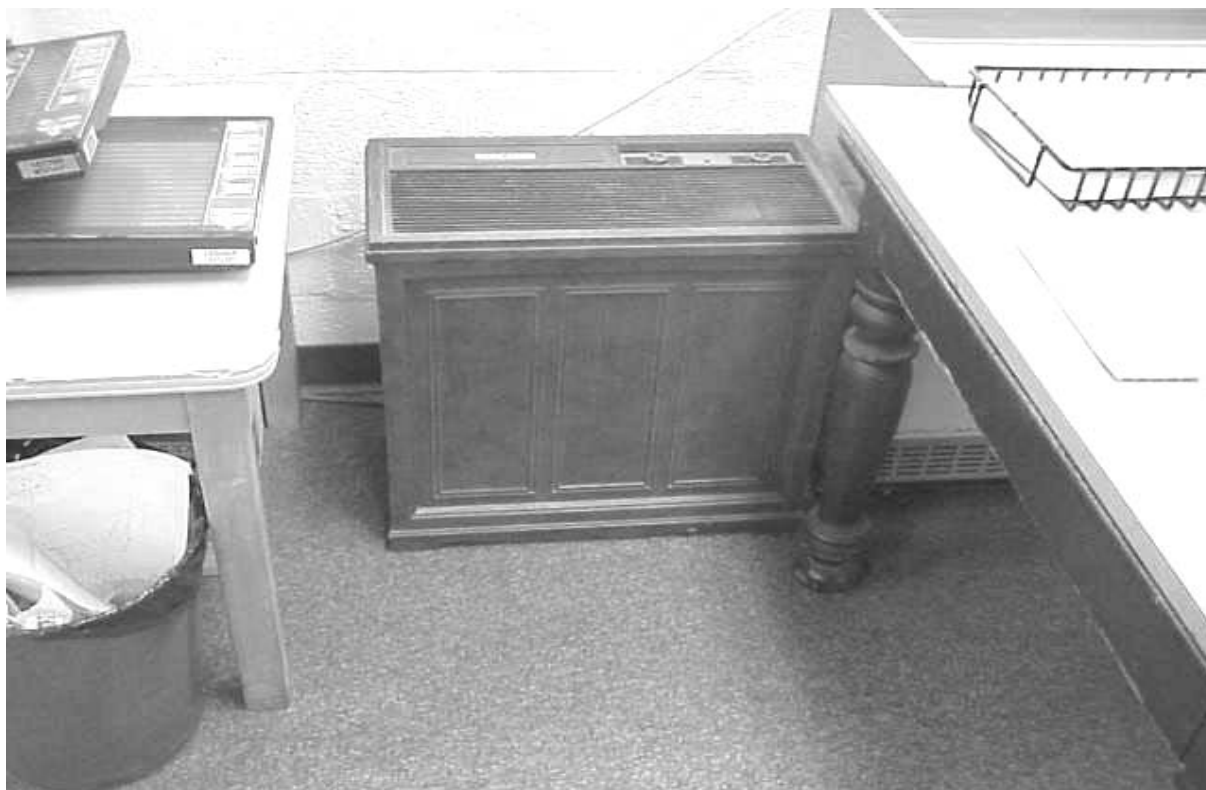
Picture 7

Humidifiers were observed in several areas (see Picture 7) with standing water in them. BEHA staff removed the covers to several of these humidifiers and noted musty/mold-type odors and mold/scale growth lining the bottom and walls of the reservoir (see Picture 8). One of the units contained approximately 6 to 7 inches of standing water. It was reported to BEHA staff by the room occupant that this unit had not been activated for over a month. Standing water can become stagnant, provide a medium for bacterial and mold growth and be a source of unpleasant odors.

Example of Humidifier Utilized in the Grafton Municipal Building

10. Clean humidifiers and dehumidifiers regularly and maintain as per the manufacturer's instructions to prevent microbial growth and/or unpleasant odors.

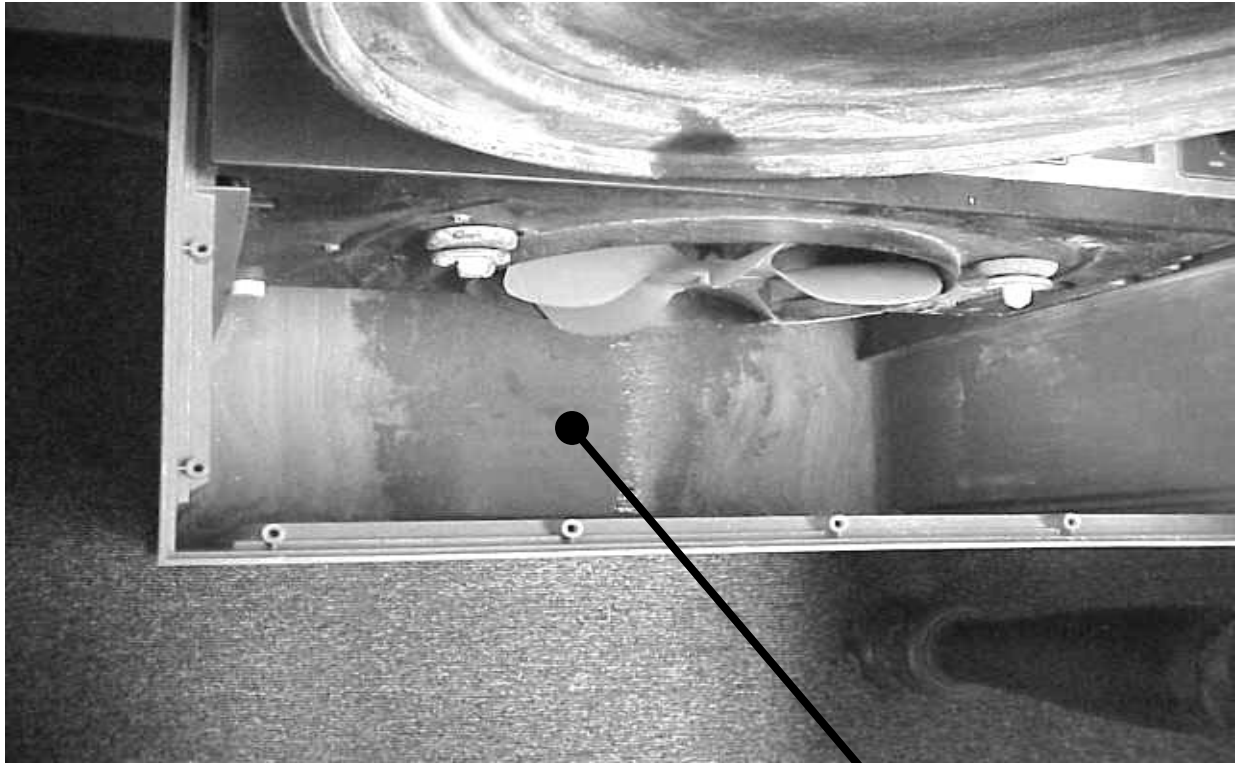
Picture 8

**Top View of Interior of Humidifier Note Unidentified Green Substance
As Indicated by Dark Stain (Possible Mold Growth)**

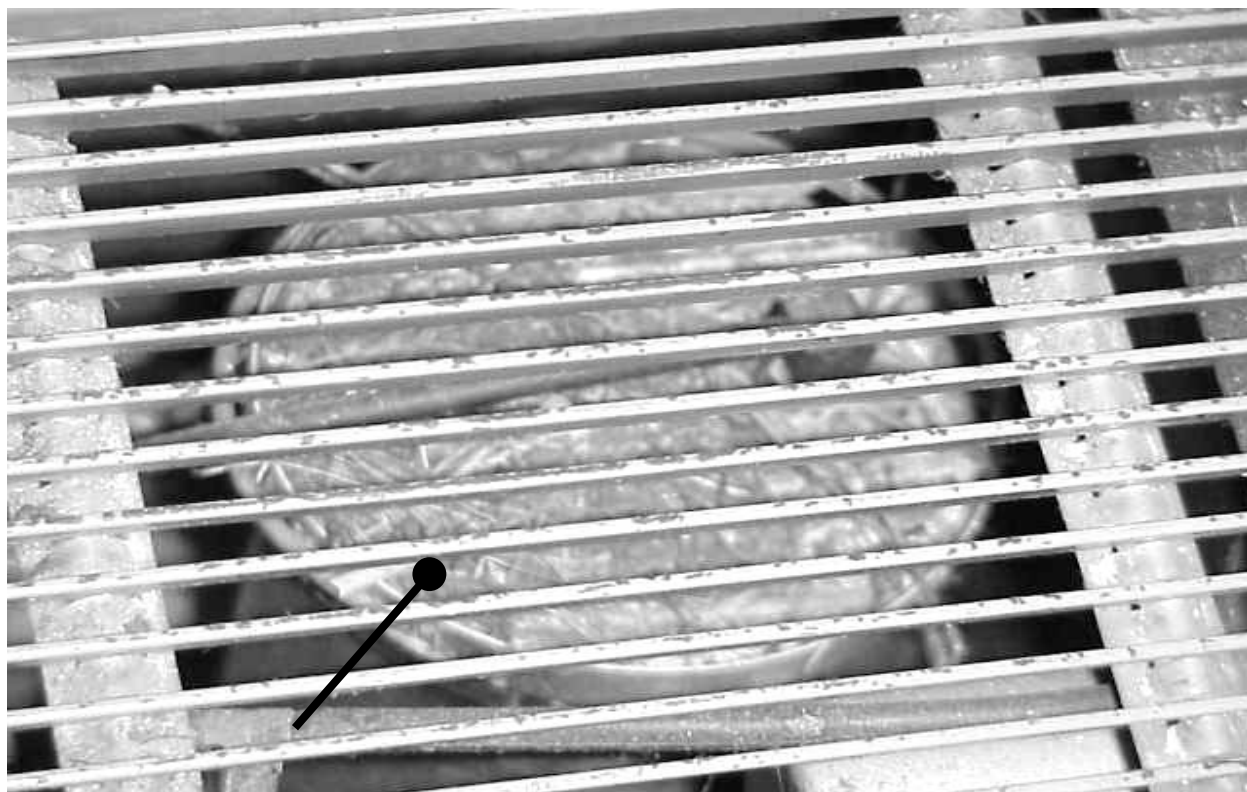
Picture 9

Plant Debris Noted in the Interior of Classroom Univent

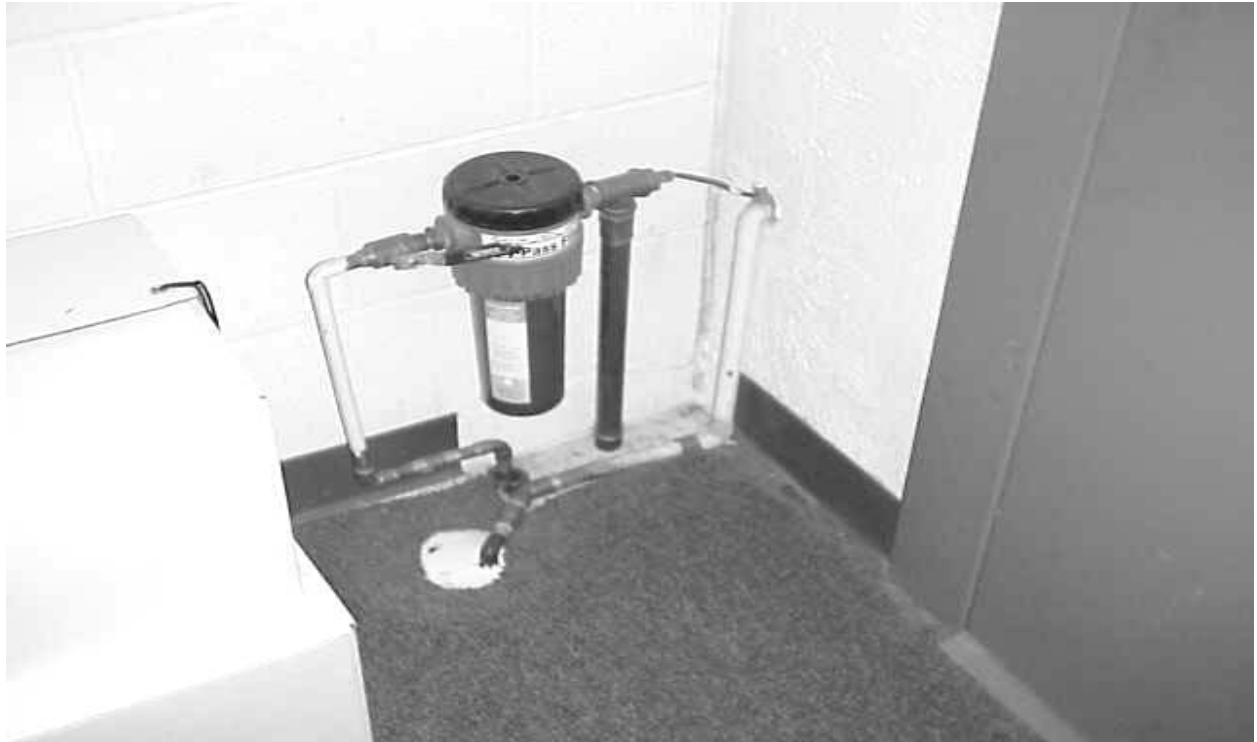
Picture 10

Uninsulated copper pipes were noted in the Town Clerk's office over carpeting (see Picture 10). When warm, moist air passes over a surface that is colder than the air; water condensation can collect on the cold surface of the pipes. Over time, water droplets can form, which can then drip from a suspended surface. The cool temperature of the metal piping would make them prone to generating condensation. Dripping condensation can lead to mold growth on porous materials (i.e., carpeting). The American Conference of Governmental Industrial Hygienists (ACGIH) recommends that carpeting be dried with fans and heating within 24 hours of becoming wet (ACGIH, 1989). If carpets are not dried within this time frame, mold growth may occur. Water-damaged carpeting cannot be adequately cleaned to remove mold growth.

Uninsulated Copper Pipes Noted in the Town Clerk's Office

13. Consider insulating copper pipes and/or removing carpeting around pipes in the Town Clerk's Office to avoid condensation and the potential of mold growth on carpeting.

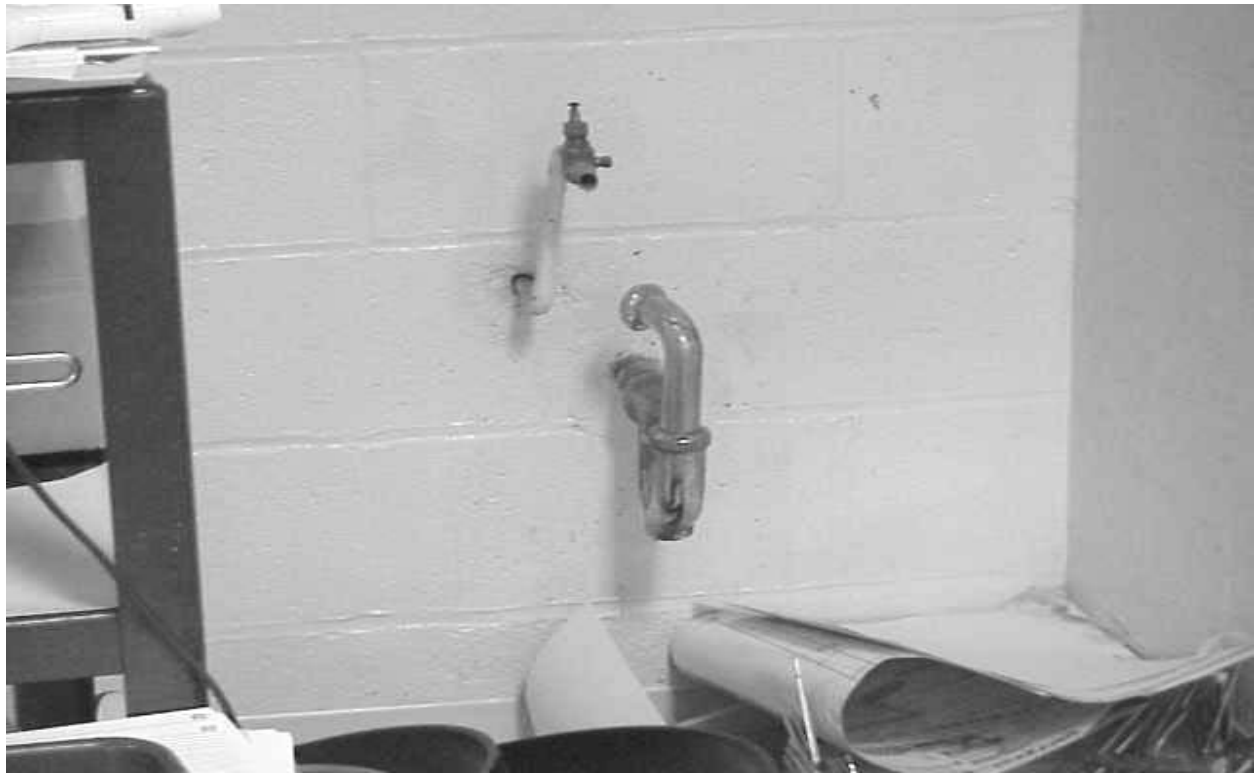
Picture 11

Abandoned water pipes were noted on the wall of the cafeteria (see Picture 11). If not in use, the traps to these pipes can dry out, allowing sewer gas to back up into occupied areas. Sewer gas can create nuisance odors and be irritating to certain individuals. These drains should be capped to prevent sewer gas back up.

Abandoned Pipes Noted in Cafeteria

11. Replace missing ceiling tiles to prevent the egress of dirt, dust and particulate matter between rooms and floors.
12. Cap abandoned pipes in cafeteria to prevent sewer gas back up.

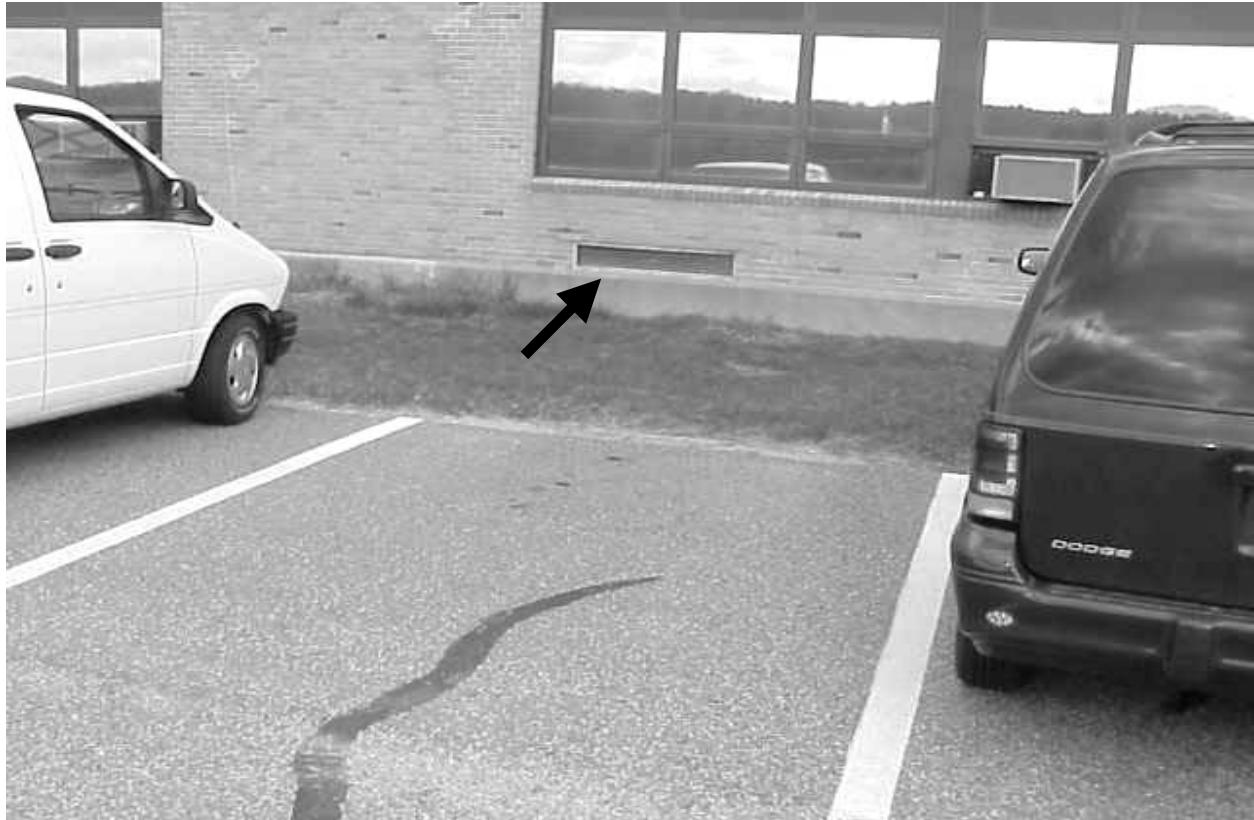
Picture 12

Complaints of vehicle exhaust odors have been reported within the building. This has been attributed to the entrainment of vehicle exhaust into the building via the ventilation system from the employee parking lot (see Picture 12) and the idling of busses at the student drop-off area. Idling vehicles can result in the entrainment of vehicle exhaust into the building, which may, in turn, provide opportunities for exposure to compounds such as carbon monoxide. M.G.L. chapter 90 section 16A prohibits the unnecessary operation of the engine of a motor vehicle for a foreseeable time in excess of five minutes (MGL., 1996).

Employee Parking Lot Note Univent Fresh Air Intake on Exterior of Building
